News from a Cruising Member

Shift Cable Replacement

Ralph Yost 3366

Aboard SAY GOOD-BYE: 41' Defever 1982

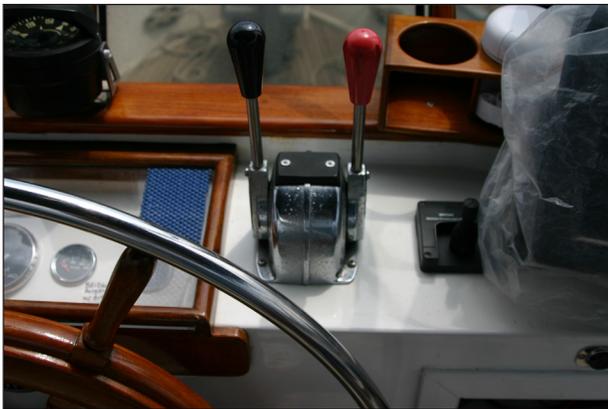
I disassembled the gear shift and throttle set on the fly

bridge. I could feel the cable disconnect and then hit the rest of it inside the sheath not far from the handle mechanism.

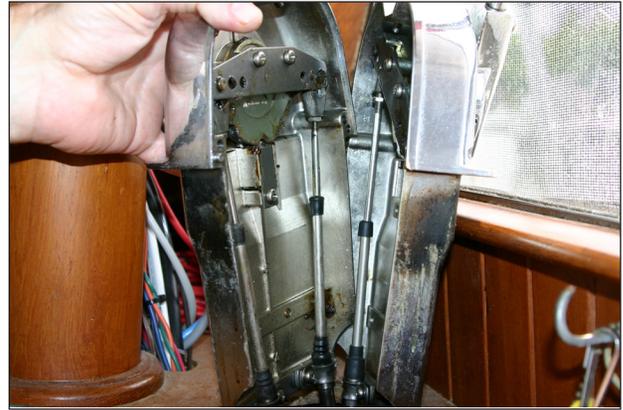
Figure 2

helm gear shift set. The cables are attached to one end of a fulcrum (pivoting) bar. Think of how a see-saw works in the playground. In the photo the gear shift is in the NEUTRAL position, which makes the pivot bar horizontal. The gear shift cable on the fly bridge is attached to the rear of its pivot bar. There is nothing attached to the front of the pivot bar. When the gear shift on the fly bridge is pushed into FORWARD, it pulls the shift cable up. At the same time, the gear shift handle on the lower helm must also travel FORWARD. This can only happen when the cable from the fly bridge is attached to the front of its pivot bar. Now the back (aft) connection of the pivot bar pulls a separate cable up. This is the cable that is connected to the transmission horizontally such that when the inner cable is pulled, the transmission lever moved FORWARD. It all works the same way in reverse but each in the opposite direction.

If you look carefully at the photos you can see the threaded rod and lock nut that goes into the bottom of a pivoting swivel cam that attaches to the end of the shift (or throttle) pivot bar previously mentioned. It hangs on a greased pin that is compressed between two of these pivot bars. If you remove the two screws in the middle top of the bar you can remove this cam, which must be done to remove the old cable and connect it to the new cable.

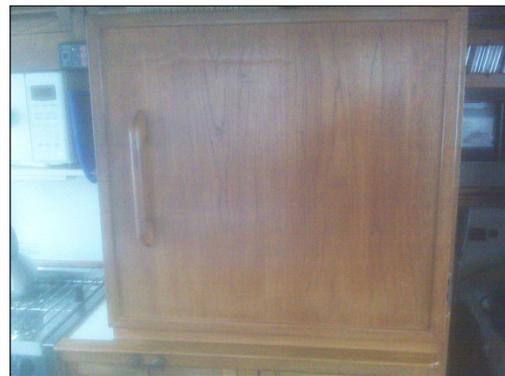
Before

Skye Castle had a custom built-in refrigerator. We loved the look of it but it wasn't very efficient. The design was a custom built stainless steel box with four inches fairly inefficient insulation and an older external 12 volt Alder Barbour compressor. Try as we might, improving the seals on the door and the seams was never enough to reduce the condensation and we always had a pool of water accumulating at the bottom.
